Abstract Presented to the Graduate School of the University of Florida in Partial  
Fulfillment of the Requirements for the Degree of Master of Engineering

USING REINFORCED EARTH WALLS FOR BLAST MITIGATION

Ronald L. Pieri

3 December 1998

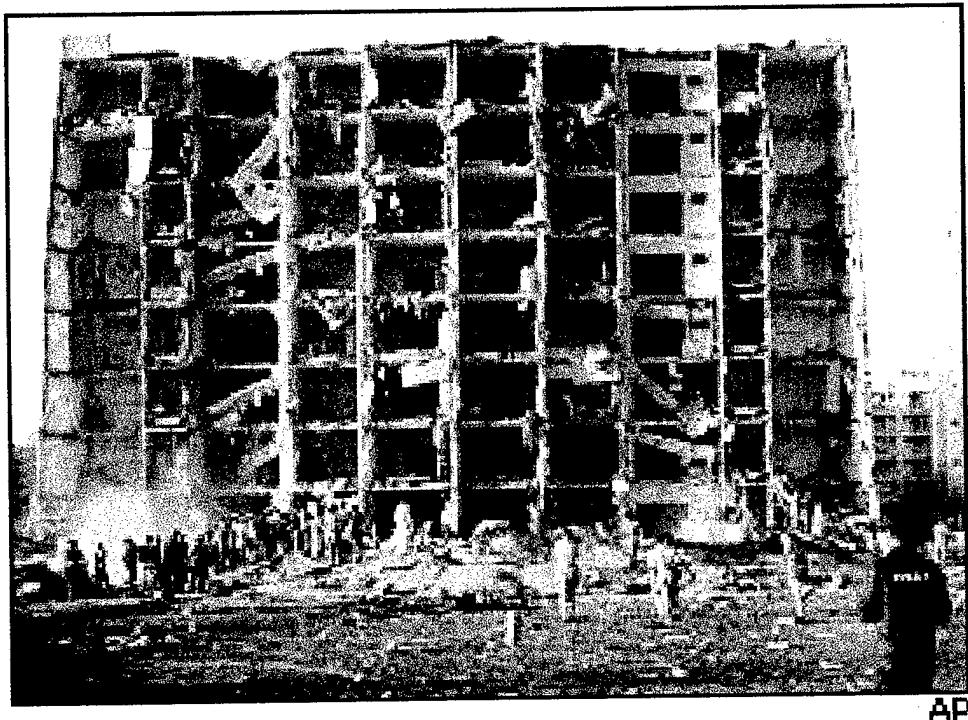
Figure 1: Khobar Towers After Bombing

The end result of the bombing for United States Soldiers and Airmen was 19 killed and approximately 500 wounded. Following the attack, the Secretary of Defense directed a

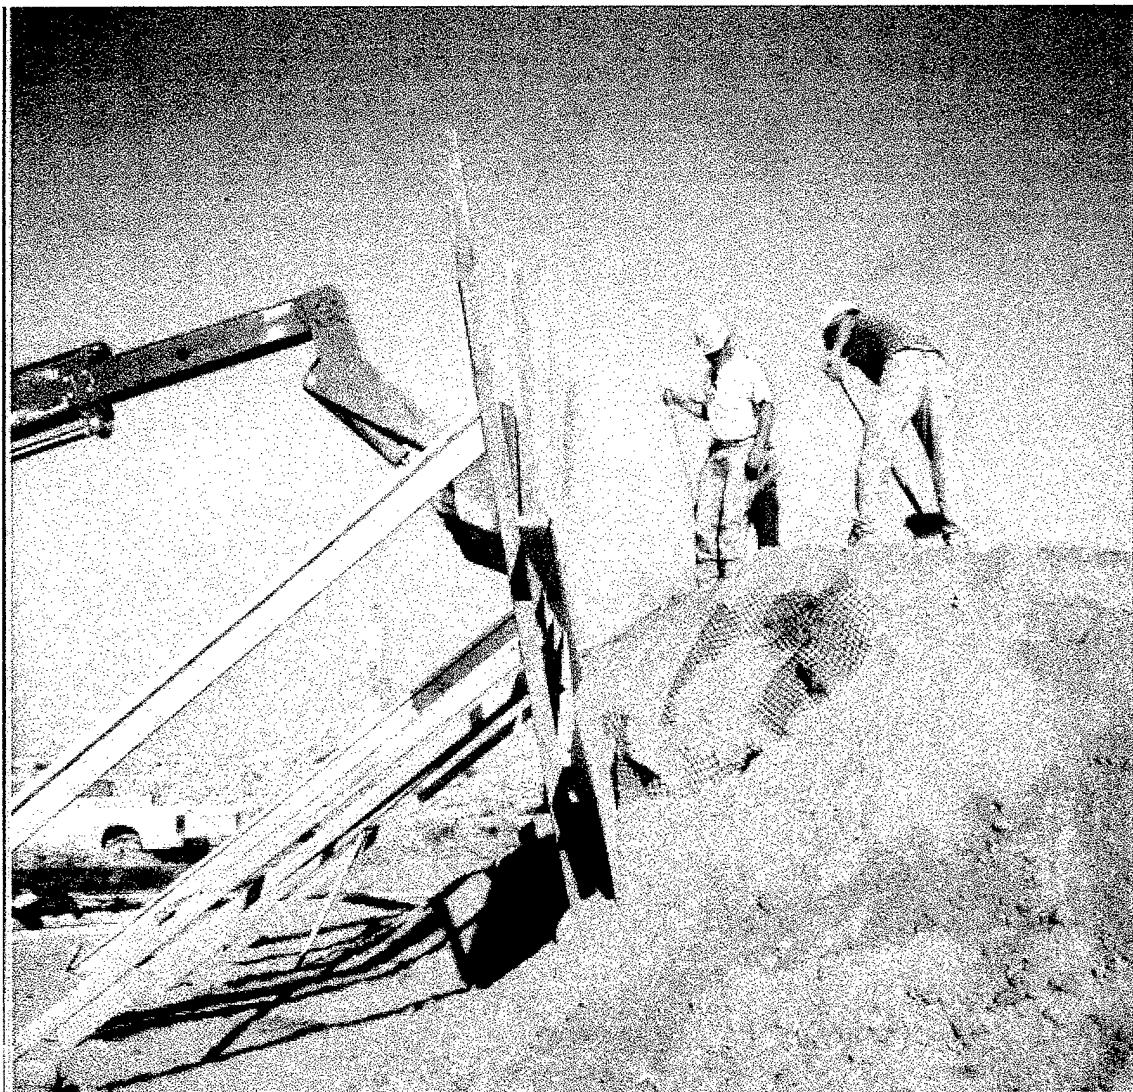
As the loader dumped one of its three cubic yard loads, one of the end posts cracked and the form wall deflected about two and a half feet.

Photograph 5.6: Collapsed Form Wall for Reinforced Earth Wall

This caused several problems. The first and most apparent was that the wall's angle increased from  $80^\circ$  to about  $100^\circ$  in the section of the form where the post had cracked. In addition, the other posts were cracking due to the increased stress that resulted from the failed post. In order to salvage this lift before the other posts failed, the lift was finished even though it was not quite three feet high. However, the form wall failure caused the same problem that was supposed to be avoided. Instead of the form

wall providing the temporary 80° angle and keeping the soil confined against the plywood, when the form wall failed, the soil fell at its natural angle of repose. Once again, this resulted in an excess amount of soil at the bottom of the lift, and a void towards the top of the lift. Also, the excess soil at the bottom caused a bulge and decreased the amount of biaxial geogrid that would be available on top of the lift. Since each lift was dependent upon the biaxial geogrid to hold the soil inside the lift, this was a significant problem. By the time the biaxial geogrid was wrapped around the lift, there was only two feet of the material left for the top of the lift. This was not enough overlap to prevent the biaxial geogrid from “pull-out failure” so six-foot sections of the geogrid were cut and spliced to the existing geogrid. The splice was overlapped approximately six inches and wire ties were fastened every three inches. After this was completed, soil was placed and spread on top of the geogrid so that the biaxial geogrid section would not pull-out if the form wall collapsed.

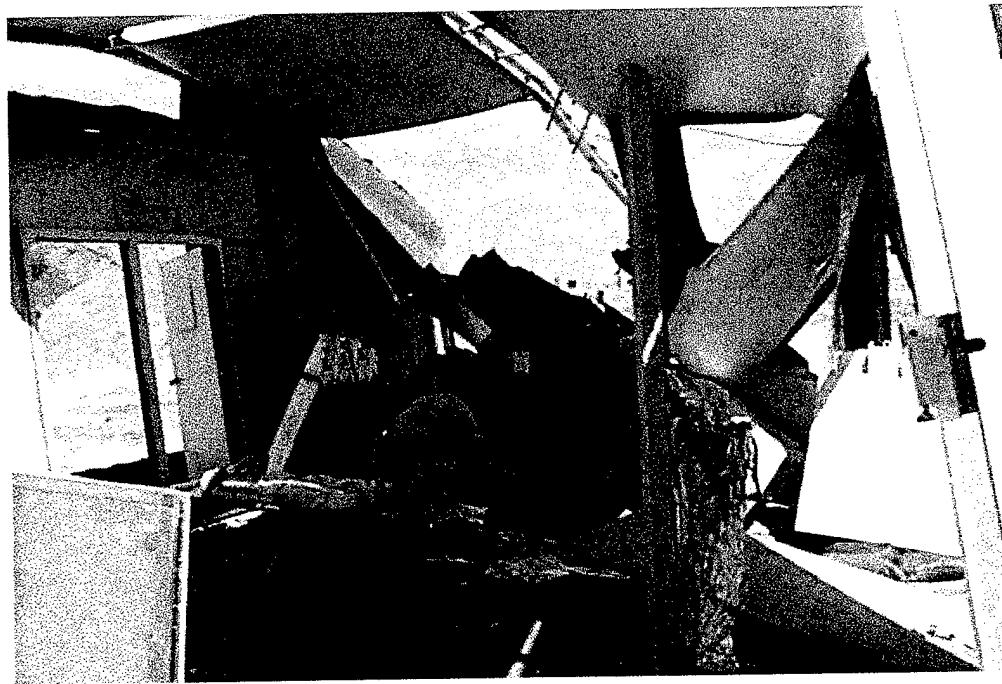
Photograph 6.5: Interior of GPS 1 after the blast.
